# Manhole Inspection Summary

Manhole # S09A1\_006MH

**Location** Address: **3601 Benson Ave**

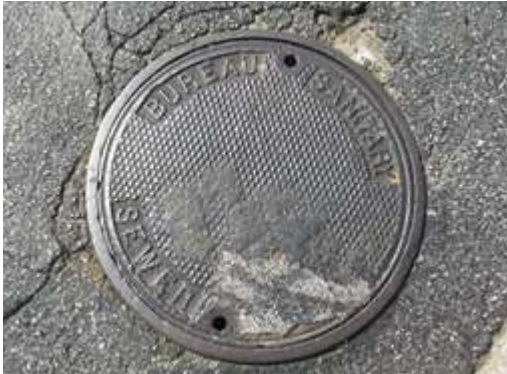
cover

.5 a/b grade

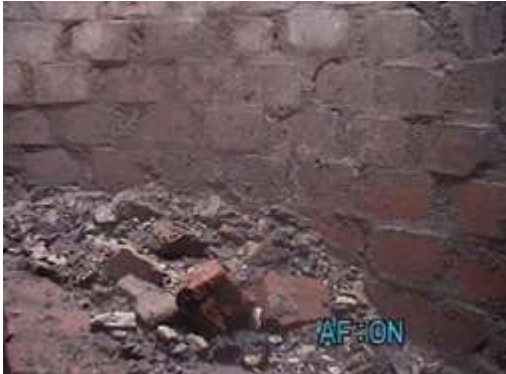
Defect 1

Heavy sediment on bench

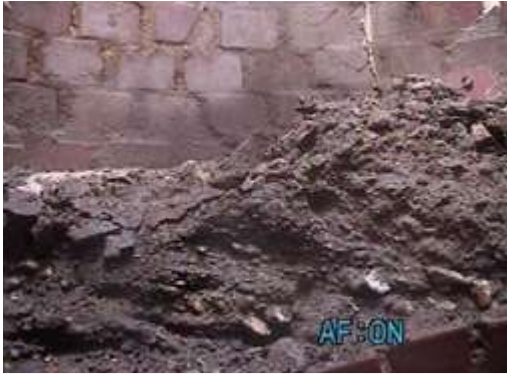
Defect 2

Heavy sediment on bench

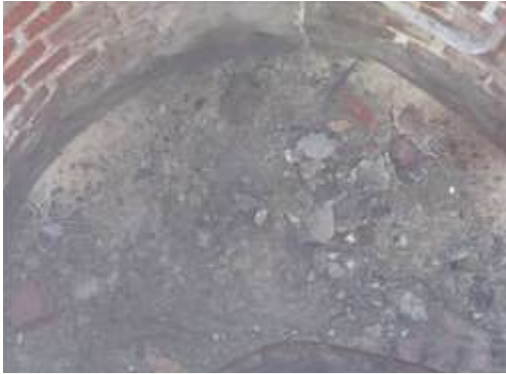
Defect 4

Sediment on bench

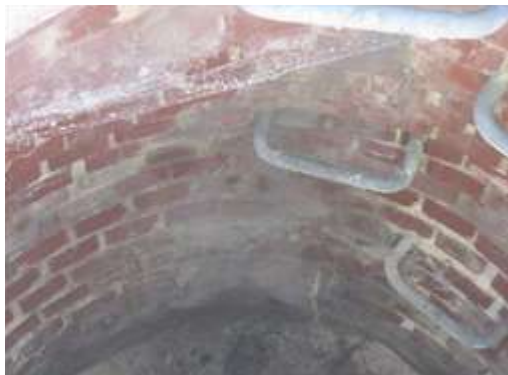
Defect 5

Infiltration along corbel and barrel wall

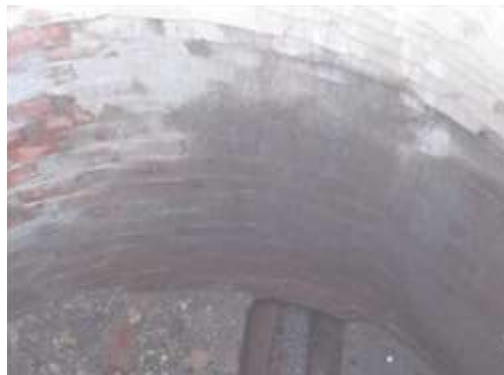
Defect 6

Infiltration along corbel and barrel wall

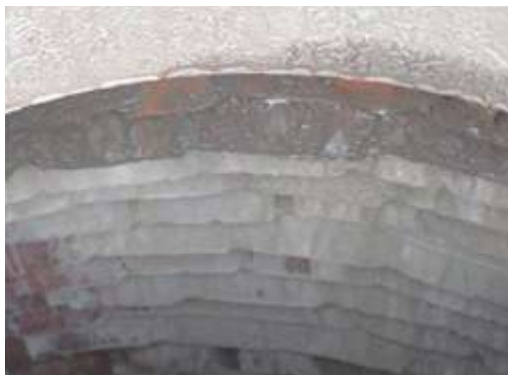
Defect 7

Infiltration @ chimney

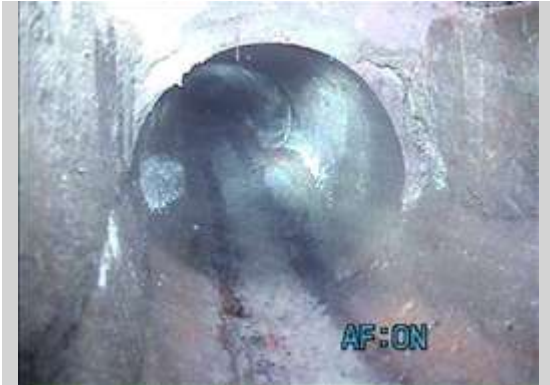
12 O'Clock Outflow

Pipe Height: **8.4** (in.) Rod and Bar (Angled)  
Pipe Material: **Clay** ☐ Pipe Lined  
Invert Depth: **7.72** (ft.) Flow Characteristics: **Slow**  
Deposits: ☒ None ☐ Mud ☐ Sludge ☐ Debris ☐ Grease  
Silt Depth: **0** (in.) Deposits Extent:  
Infiltration: **None** Pipe Seal Cond: **Sound**

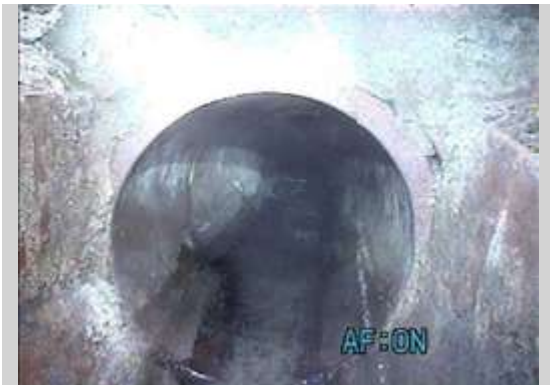
9 O'Clock Inflow

Pipe Height: **8.4** (in.) Rod and Bar (Angled)  
Pipe Material: **Clay** ☐ Pipe Lined  
Invert Depth: **7.43** (ft.) Flow Characteristics: **Slow**  
Deposits: ☒ None ☐ Mud ☐ Sludge ☐ Debris ☐ Grease  
Silt Depth: **0** (in.) Deposits Extent:  
Infiltration: **None** Pipe Seal Cond: **Sound**
